History – Timeline of the castle ruins

The 2004 restoration

MEIRINGEN
Resti Castle ruins

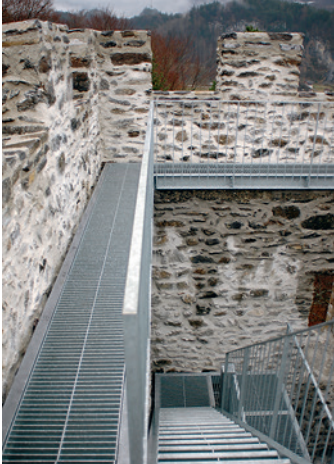
Below: Cross-section of the tower showing the new steel staircase and viewing platform.

Having carried out a thorough architectural examination and building survey, the restoration project comprised new battlement capping and repair work on the lime mortar joints. Following the construction of a steel staircase, a new viewing platform was created and a better insight gained into the numerous preserved medieval features.

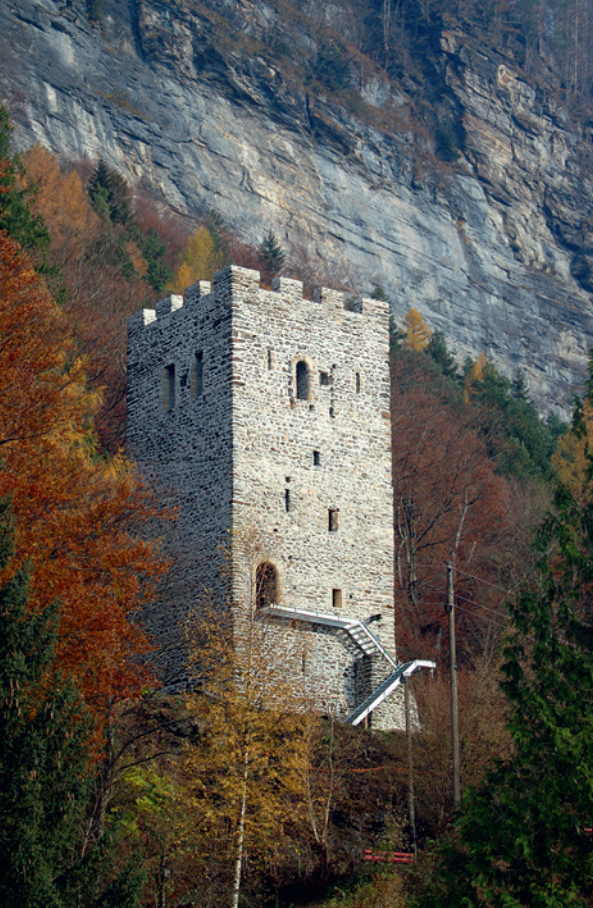
Architectural survey of the tower with its various building phases. Sc. 1:150.

- original tower from the period around 1250.
- first addition of a storey around 1300.
- second addition of a storey around 1390-1400.
- medieval(?) wall plaster.
- restoration in 1915/16.

The core of today’s tower was built around 1250. The lintels and window sills preserved in the masonry have been dated to this period by dendrochronology. However, there was probably a predecessor building, because the first floor still contained timber components, i.e. remnants of floor joists and a lintel of the south window, which belonged to an earlier structure that dates back to the period around 1180. This

Around 1300 a storey was added, whose function, however, remains unknown. The roof was still monopitched and sloped towards the south. In contrast to its predecessor, however, it was lowered and concealed behind the battlements, and thus no longer visible from the outside.

Yet another addition was built in 1390–1400 and consisted of a further storey above a fireproof defence platform, which provided protection against the dreaded incendiary arrows. The platform consisted of beams set very closely together which carried a heavy floor probably made up of floor boards and stone slabs set in lime mortar. This construction was covered with a saddle roof which was

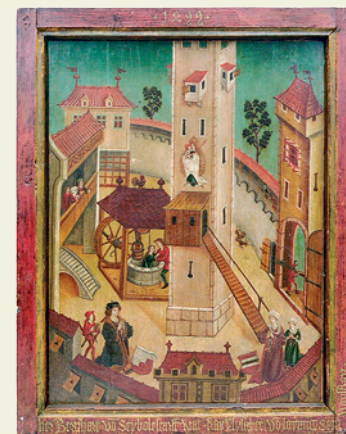
Tower with elevated battices. Votive tablet by Bernhard von Seyboldsdorf, 1499. Heimathaus Schärding, Upper Austria.
